# NATIONAL TRANSPORTATION SAFETY BOARD

## AIRCRAFT ACCIDENT REPORT

RUNWAY OVERRUN DURING LANDING  
AMERICAN AIRLINES FLIGHT 1420  
MCDONNELL DOUGLAS MD-82, N215AA  
LITTLE ROCK, ARKANSAS  
JUNE 1, 1999

**NTSB/AAR-01/02  
PB2001-910402  
Notation 7195A  
Adopted October 23, 2001**

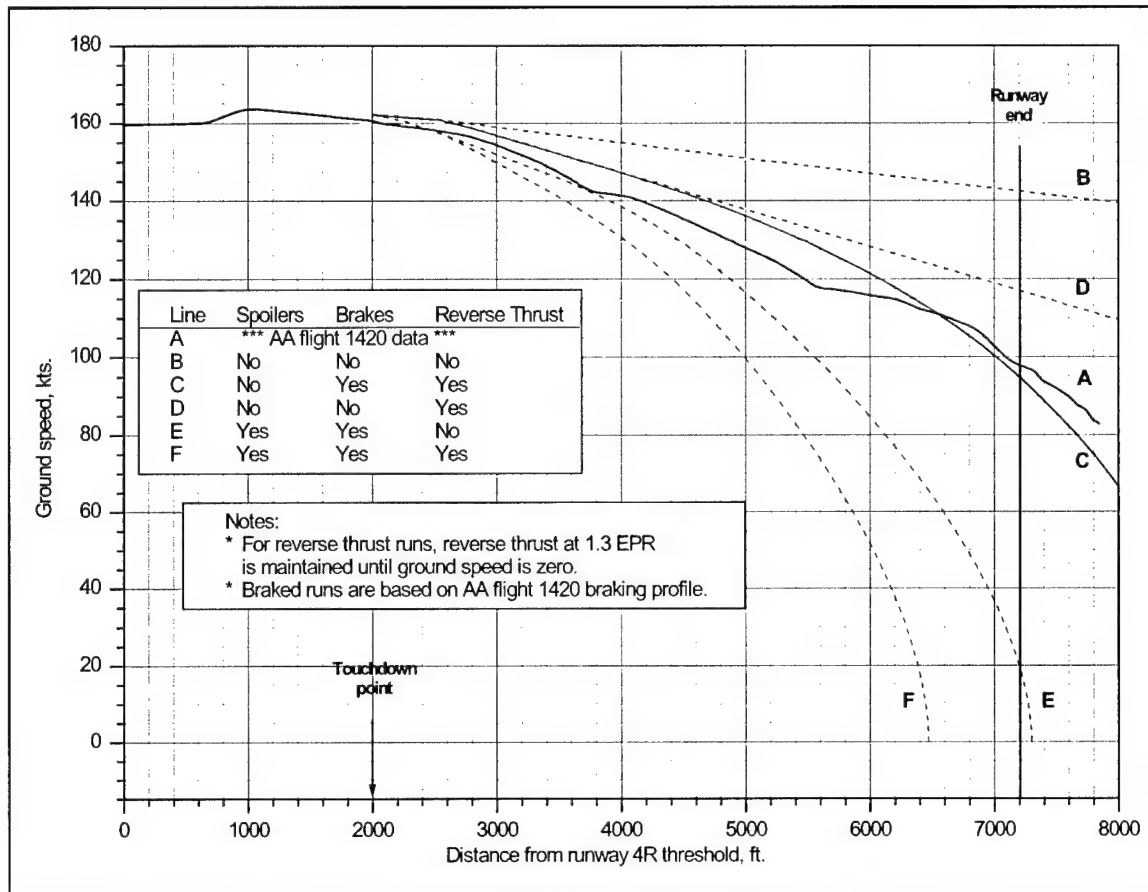
**Figure 16.** Effects of Spoilers, Brakes, and Reverse Thrust on Stopping Distance

With no braking, spoilers, or reverse thrust, the airplane would depart the runway with a ground speed of about 142 knots, which is 45 knots faster than the flight 1420 airplane. With no spoilers or brakes but with a constant, symmetrical reverse thrust at 1.3 EPR, the airplane would leave the runway at 117 knots, which is 20 knots faster than the flight 1420 airplane. With no spoilers but with 1.3 EPR reverse thrust and the flight

1420 braking profile, the airplane would have departed the runway at 95 knots. This computer run matched the flight 1420 data best and indicated that the accident airplane experienced a braking coefficient of at least 0.21 to 0.23 at speeds between 160 and 140 knots, respectively.<sup>96</sup> Figure 16 shows the results of the computer runs compared with the flight 1420 profile.

Two additional computer runs demonstrated that proper spoiler deployment is critical to deceleration and stopping distance. Without reverse thrust and with the spoilers deployed and the flight 1420 braking profile, the airplane would depart the runway at 20 knots, which is 75 knots less than the airplane with no spoilers but with reverse thrust and braking. With constant reverse thrust, deployed spoilers, and the flight 1420 braking profile, the airplane could have stopped about 700 feet before the end of the runway.
